1994 *Samuel P. Ely* Restoration

Project Report

Kenneth Merryman
August 11, 1995

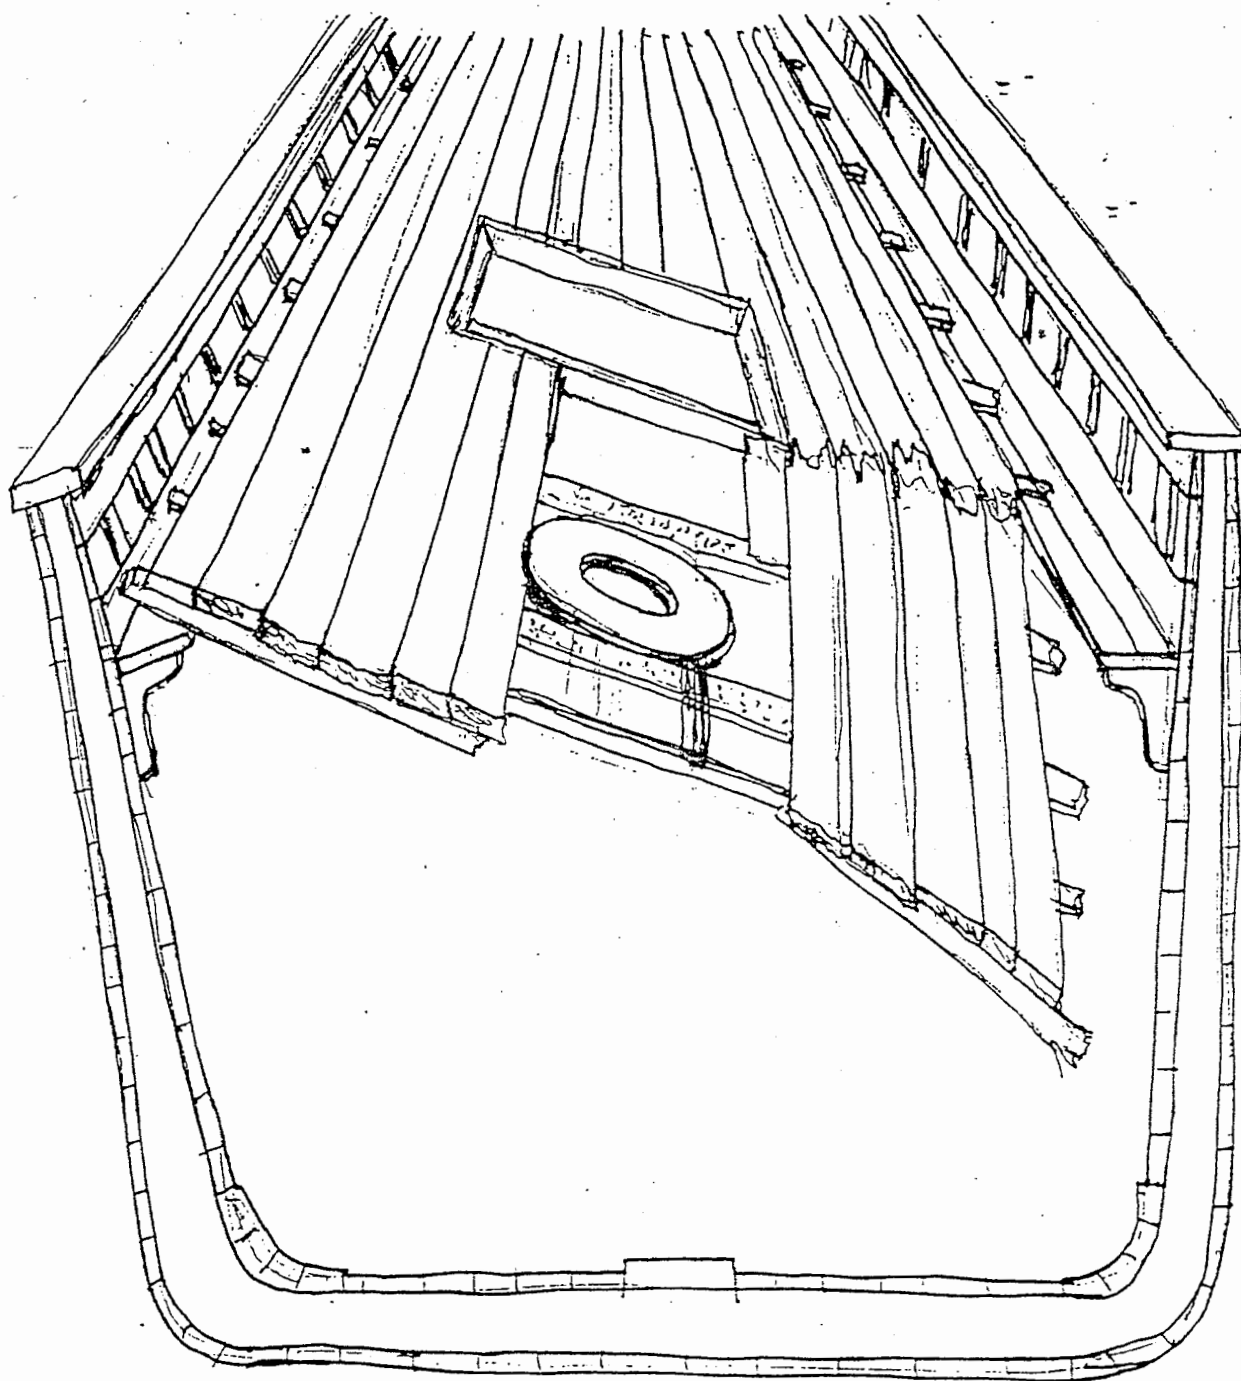
As they lean out, the weight of the structure has caused the sides that support the deck to spread. As the fasteners and deck beams have deteriorated, the hull has spread to the point that at the forward part of the deck the hull was wider than the deck beams. This caused a 20 foot section of the deck to collapse. If this process were allowed to continue, eventually the entire starboard side of the ship would fall to the outside and the entire deck would collapse. (See figure #3). For the *Ely* the rate at which this spreading was occurring accelerated considerably after the breakwall construction. Those of us that were monitoring the deterioration estimated that, if left unchecked, it would be less than five years until the wreck collapsed entirely.

Figure 3 Ely Cross-Section Showing Deck Damage
Prior to 1994 Restoration

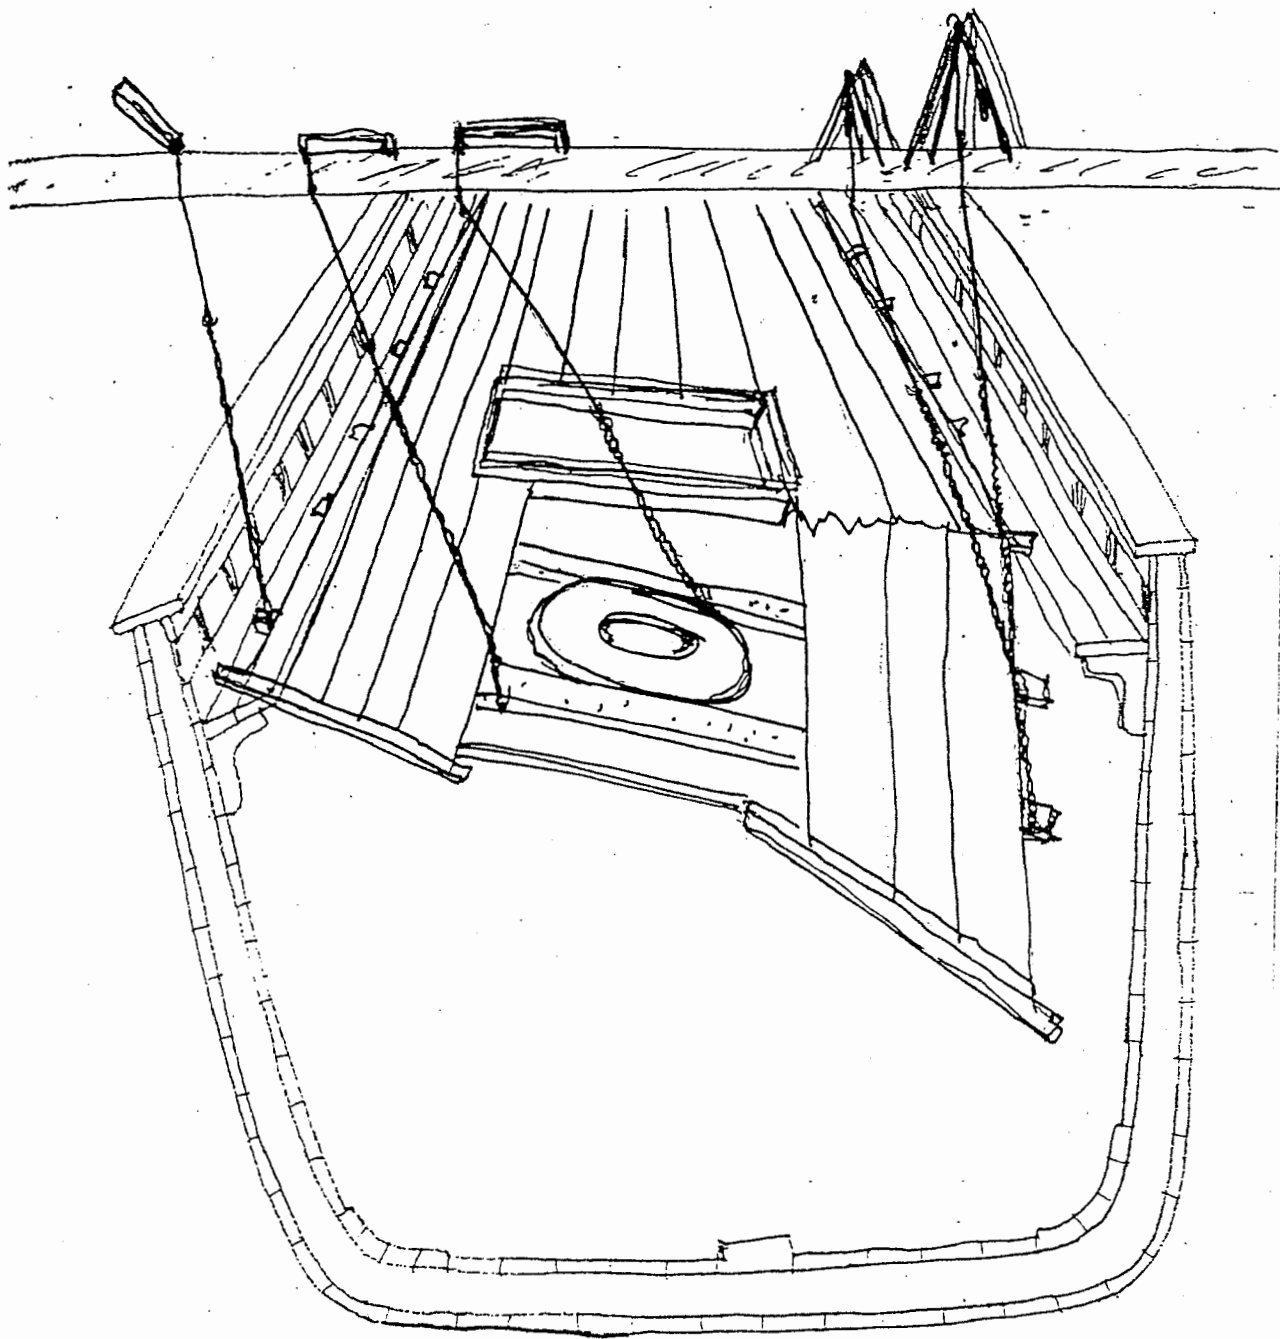
Figure 4 Winches Set to Lift Deck Up Toward Starboard

The next day the deck was lifted. Since the deck had dropped down under the shelf on the port side, we connected the chains so the winches would pull the deck up and to the starboard. We almost totally cleared the port shelf with this approach except for one deck beam. The decision was made to notch the shelf two inches to allow the beam to clear. Jerry Provost did this by auguring holes side by side in the shelf along the width of the beam. We had to use the auger since we neglected to bring a saw. I might add a saw was the only piece of equipment we lacked in the project, which is pretty good considering the size of the project.

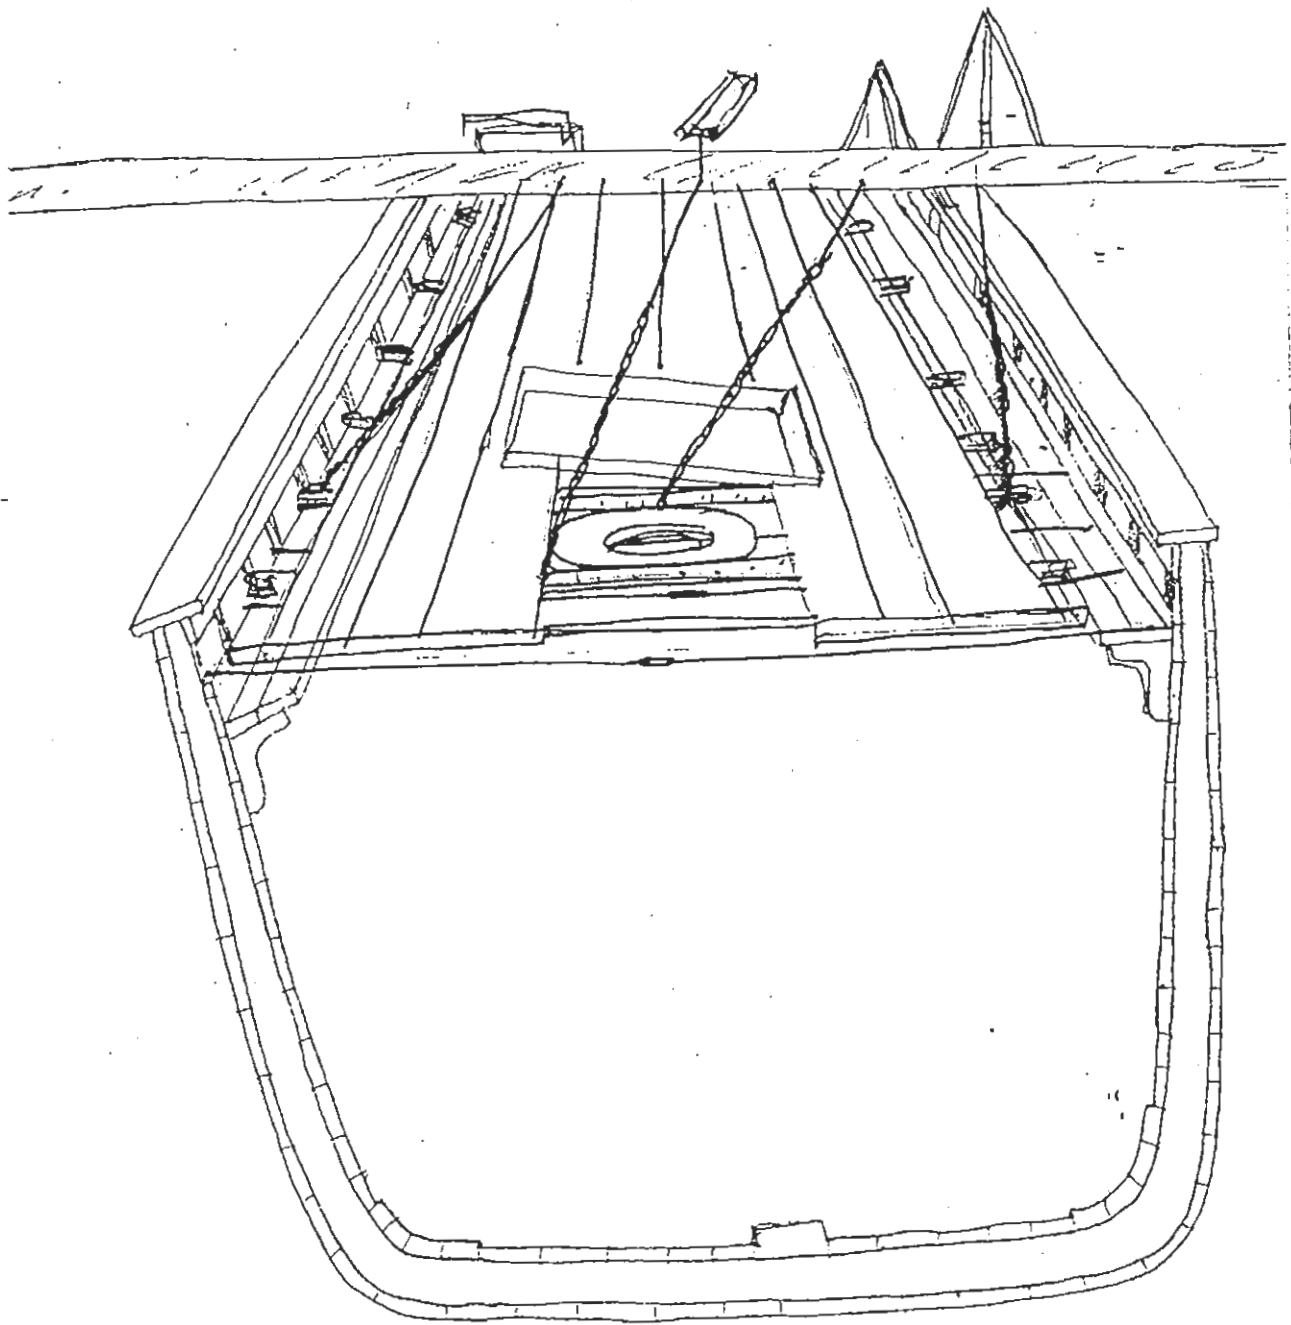
Deck Lifted
Figure 5 Winches Set to Pull Deck Back to Port

Once the rods were in place and tightened the deck was ready to be set back down. We reached that point late Sunday evening. While most of the crew was tearing down equipment in the rain which had started in the afternoon, Ben Erickson and I directed the lowering of the deck. To do this we reconnected the chains - one by one to pull the deck back to the port side. As we lowered the deck it moved over a little but not enough to get the deck beams on the port side shelf. We

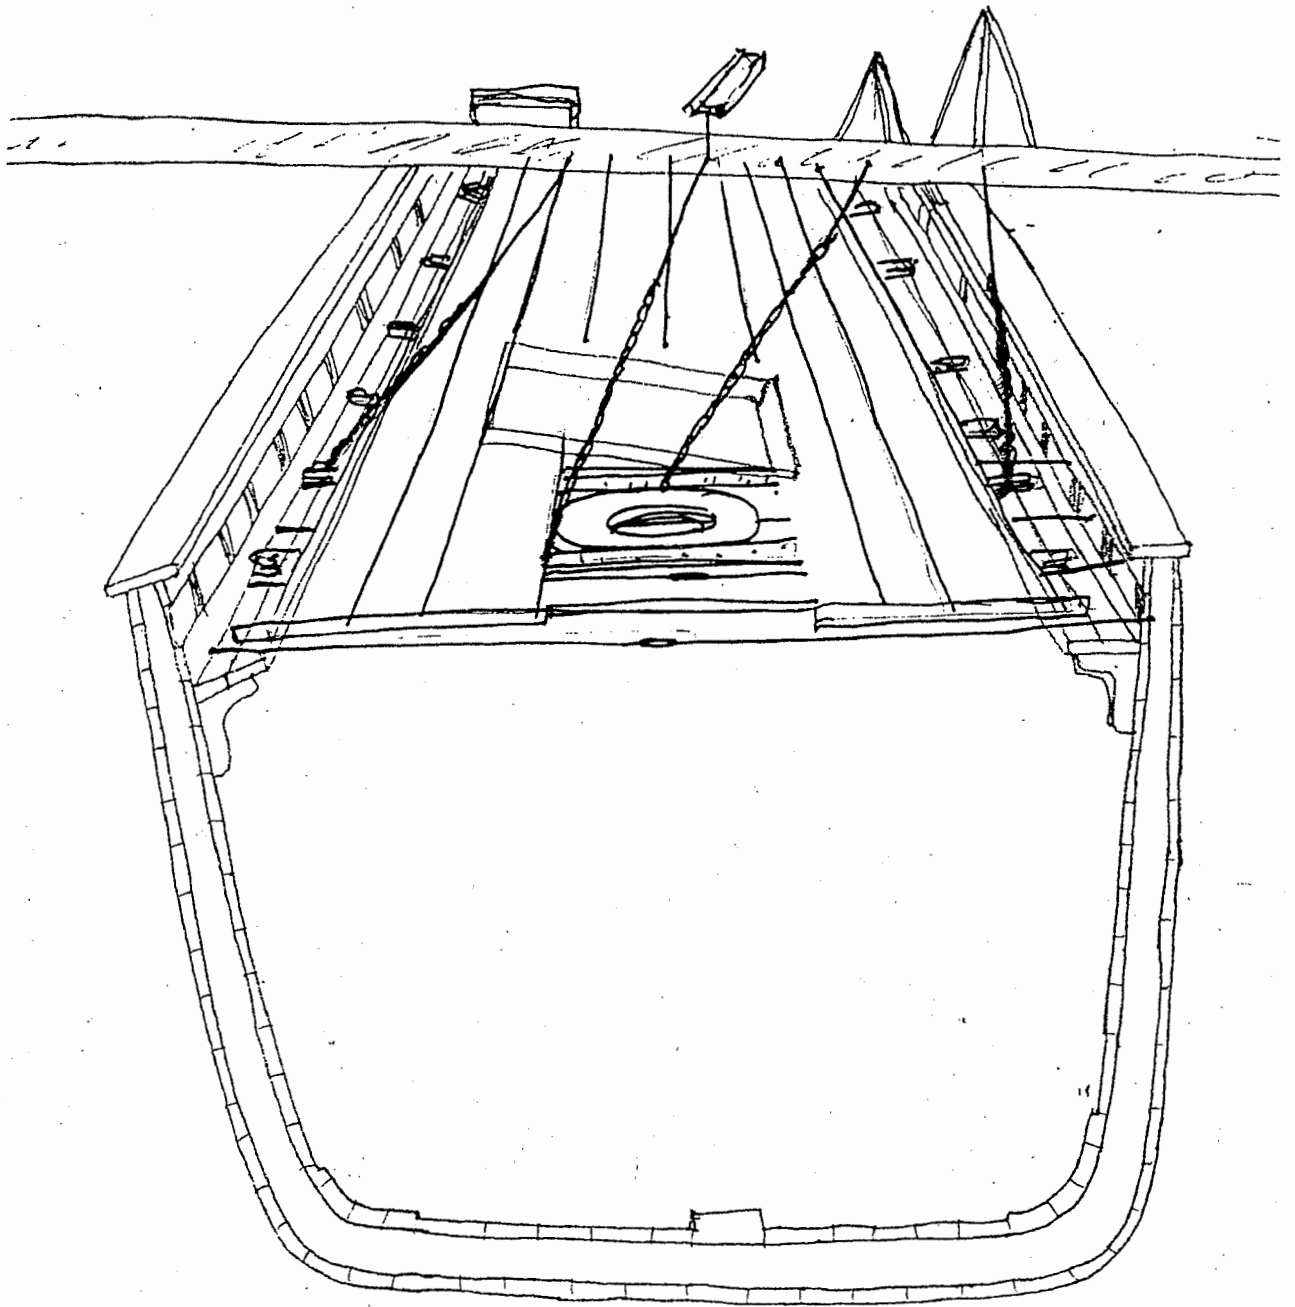
Deck Successfully Set Back On Shelf

needed to move it another six inches to make sure it was firmly on the shelf. Ben and I both stood on the starboard edge of the deck and jumped a few times. We hoped to bounce the deck enough to get it to move. The trick worked and the deck slid nicely into place just where we wanted it. After clean-up that is the way the deck sat until spring when we made the next effort.
