The 2007 SS America Project Report Addendum

By Ken Merryman
Project Manager

2007 Repair Tasks

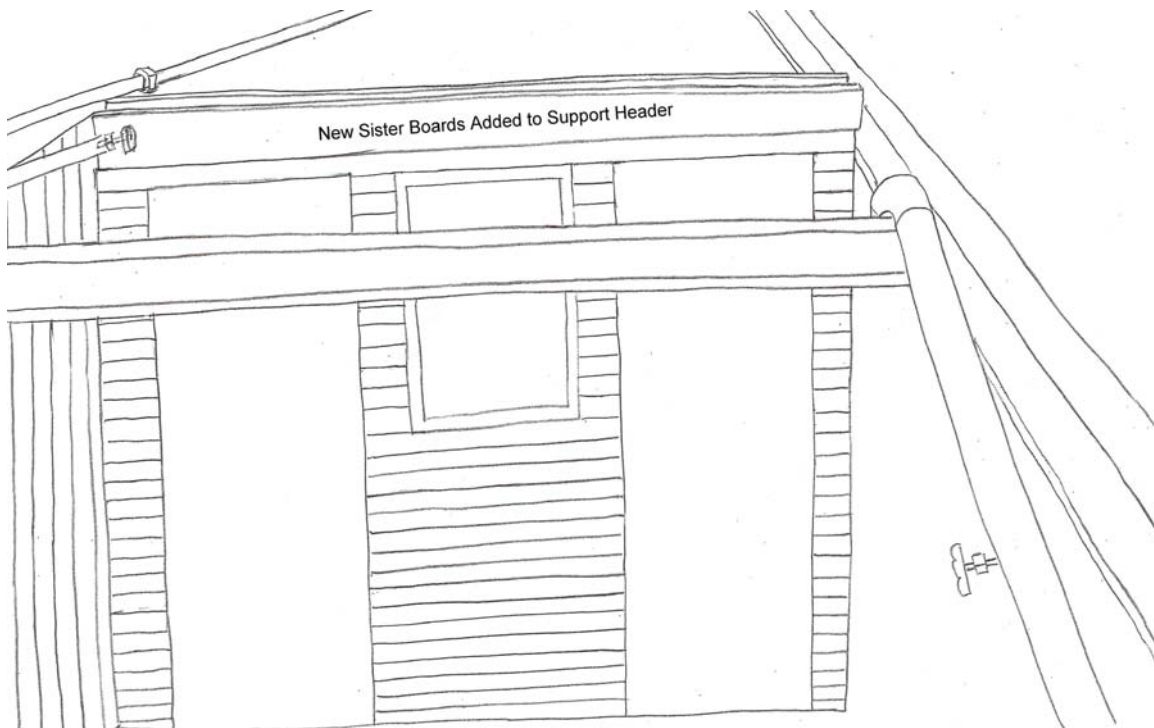
1. The starboard upper engine room divider wall (between the engine room and the two engineer's quarters) buckled in one of the doorways and was bent over farther into the upper engine room. This wall is a light weight non-load bearing wall. The damage was probably the result of the deck being pulled off of the area a few years ago. We put back most of the decking in 2001 – at least all of the pieces we could find, which has maintained the integrity of the other walls of the chief engineers quarters, but it still left some of this wall unsupported. This was a fairly easy fix to pull the wall back into place and add an additional header board to the top and a pair of oak sisters on the sides of it to maintain its integrity. We maintained the original header since it had just pulled out of the top of the wall.

Illustration 1: The view of the wall from the starboard side amidships looking toward port.

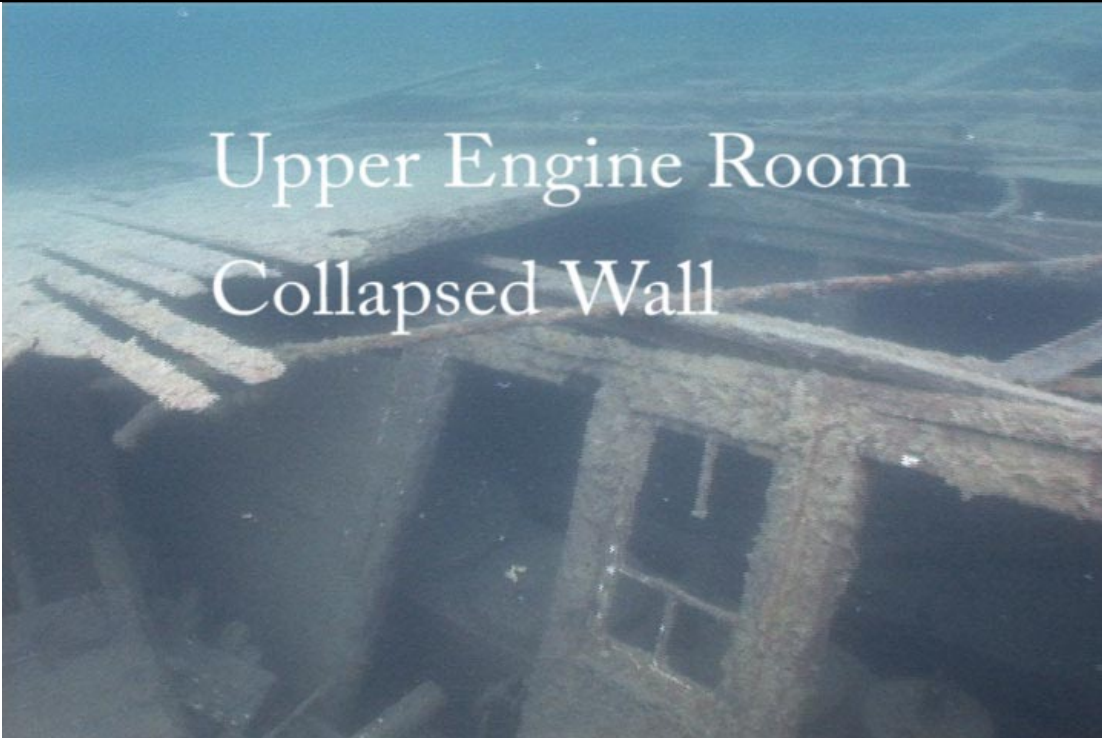
Upper Engine Room Collapsed Wall

Top view of the collapsed wall before project

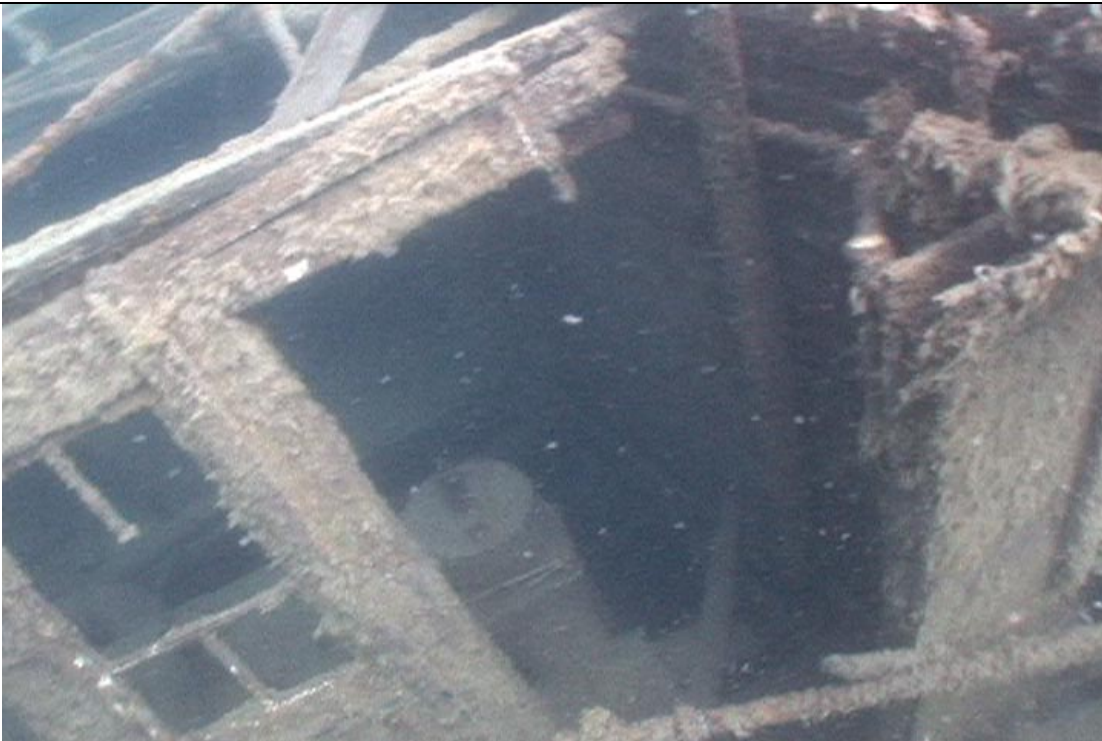
The wall broke at the corner of the forward door header.

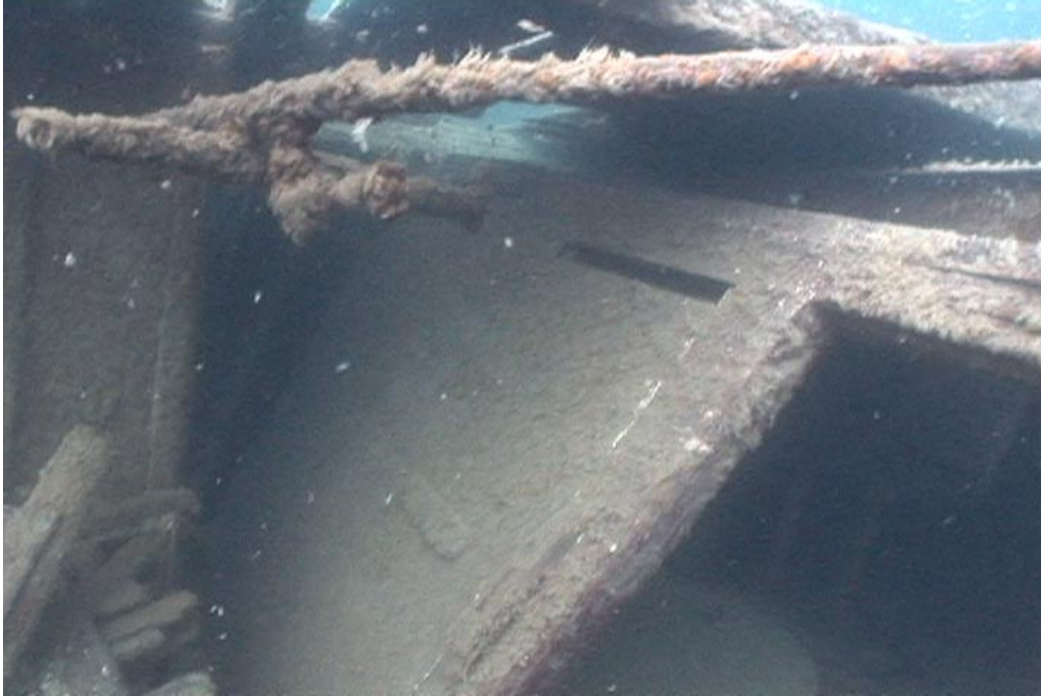
The broken wall leaned into the upper engine room.

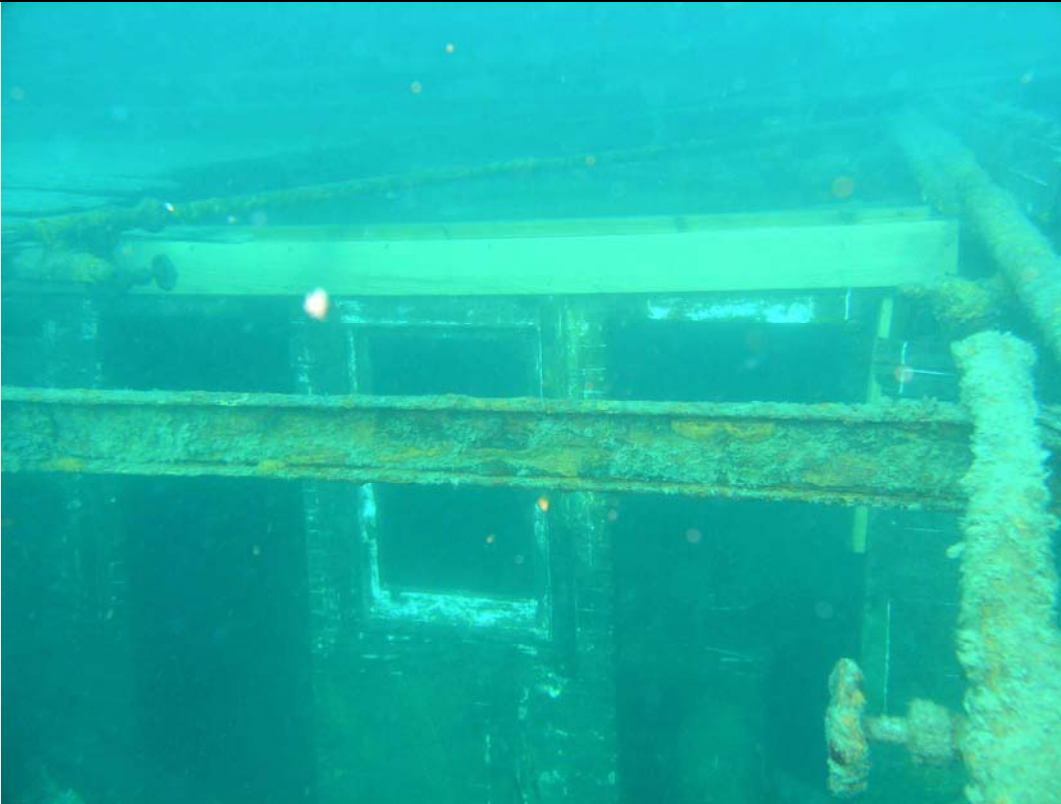
After project repairs the wall is upright and in place. By spring the new oak will discolor to the same color as the surrounding wood and will be scarcely noticeable as an addition.

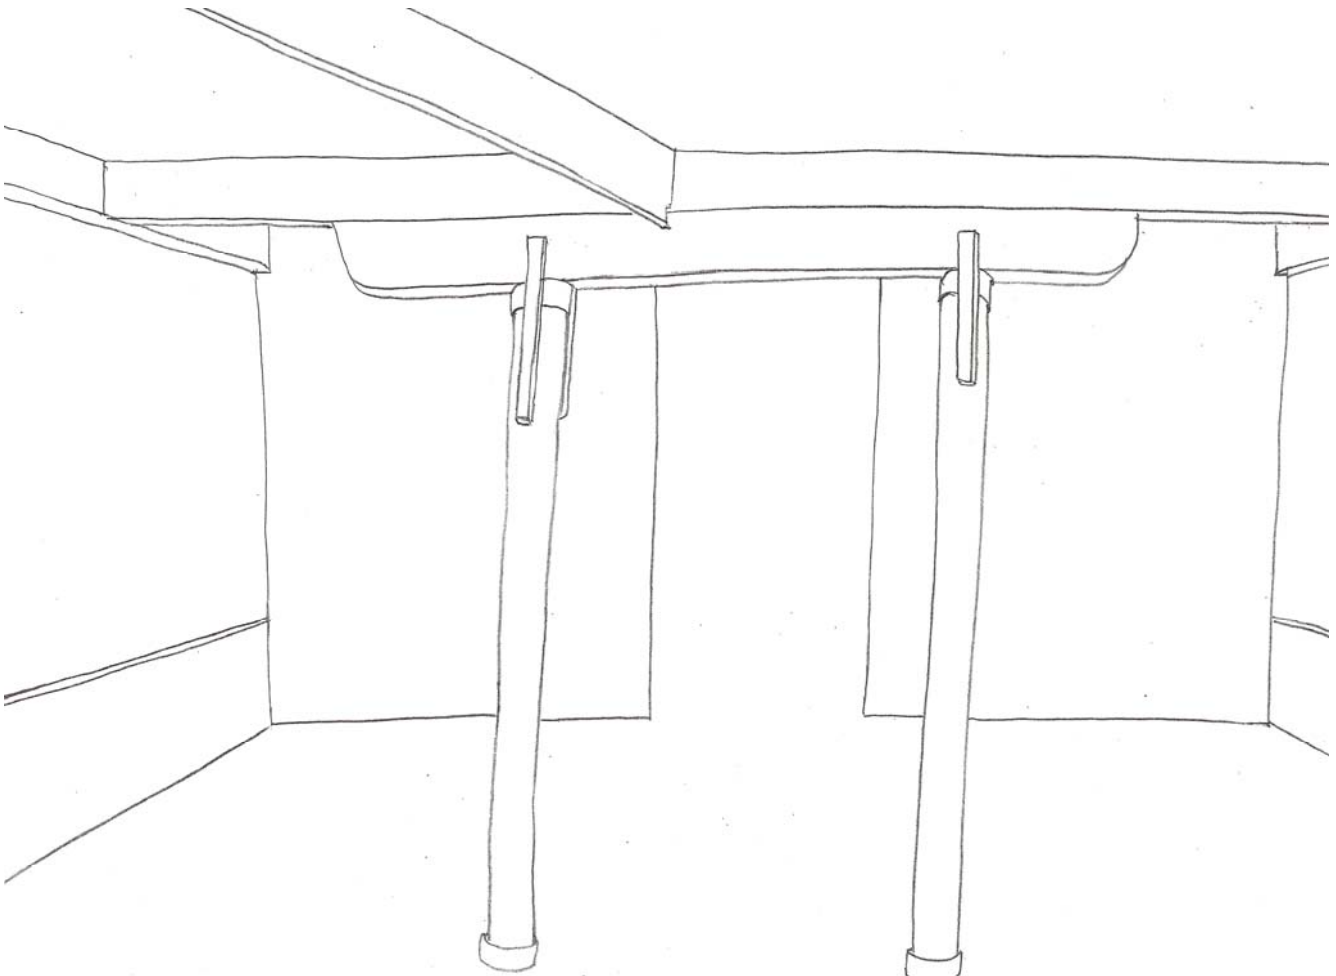
3. Three of the four posts on the open after deck had fallen down again. We fixed these on the last project, but apparently didn't do a good enough job. We were unable to find one of the posts. This time we moved the base of the posts so the posts were perpendicular to the deck as they would have been originally, then shimmed them into place so they actually can bear some of the load of the collapsing boat deck. We also added battens to attach the posts to the beams they supported to insure the beams don't move out of position and the posts don't slip off the beams. Now the posts not only look like they once did, they also give the boat deck three more legs to stand on.

Illustration 2: The final configuration of the turned posts supporting the boat deck on the open after deck. Note the cleats or battens that were added to the tops of the posts to hold them in place under the beam. The bases of the posts are the original plumbing pipe caps set on shim blocks.

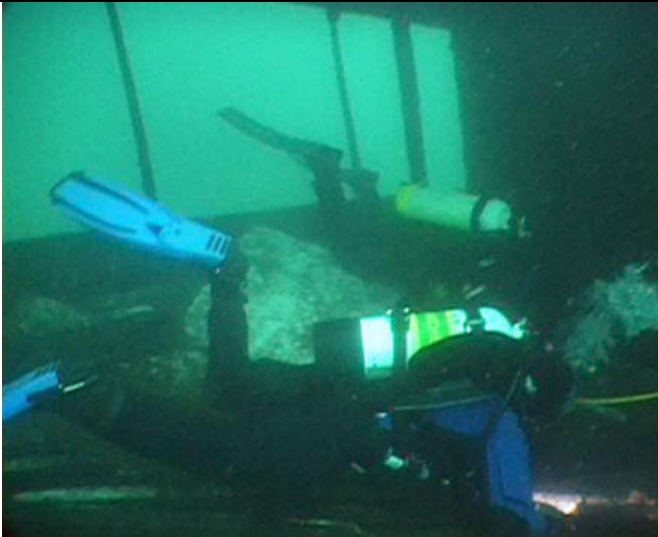
Divers measure support post base location on open afterdeck.

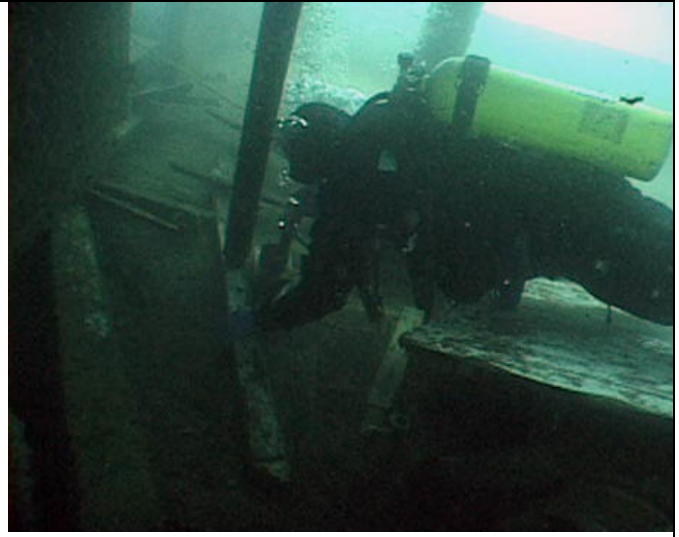
GLSPS diver fastens support post base to open afterdeck while supporting post on a loose board.

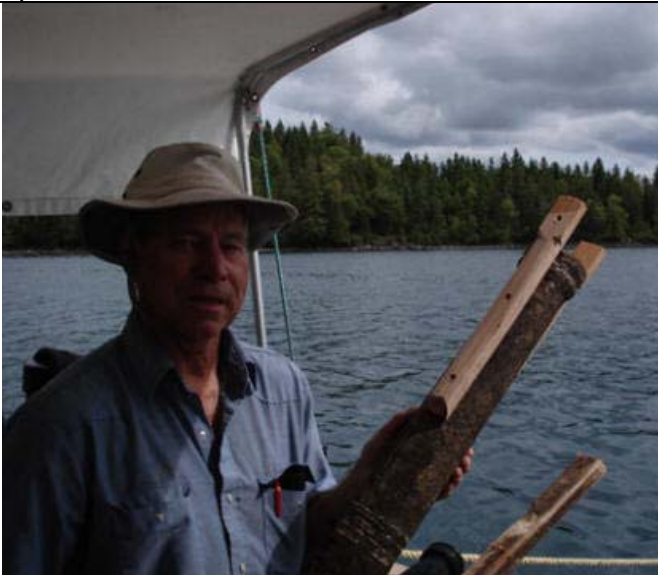
GLSPS carpenter and building wizard. Ken Knutson shows off the cleats added to the afterdeck posts to fasten them to the supporting beams.

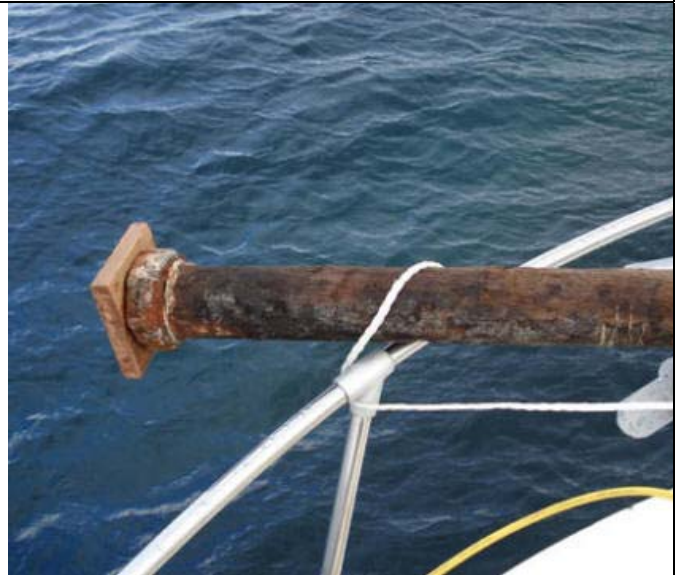
We added a block to the base of the posts to shim them to the proper length. Note the original metal pipe cap which served as the base for the post.

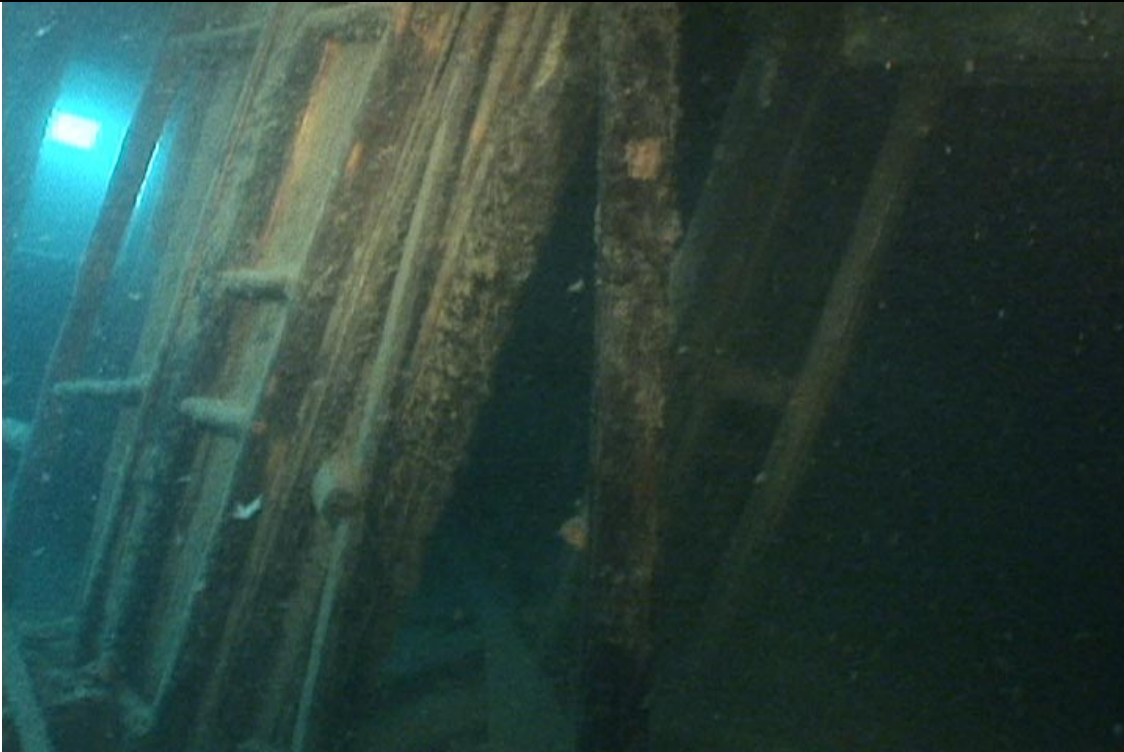
4. The rounded corner tongue and groove woodwork on the purser's office was peeling off and was re-fastened using screws and angle brackets to hold it in place to the deck and backing boards. The wood of the cabin beams is getting mushy so there isn't much to fasten to anymore. The integrity of the wood varies from board to board depending on whether the board was the heartwood or sapwood part of the tree.

The vertical piece of wood was part of the curved corner of the purser's office and was loose and about to join the heap of loose boards on the deck. We re-fastened it into place using screws and angle brackets to restore the visual integrity of the corner structure.

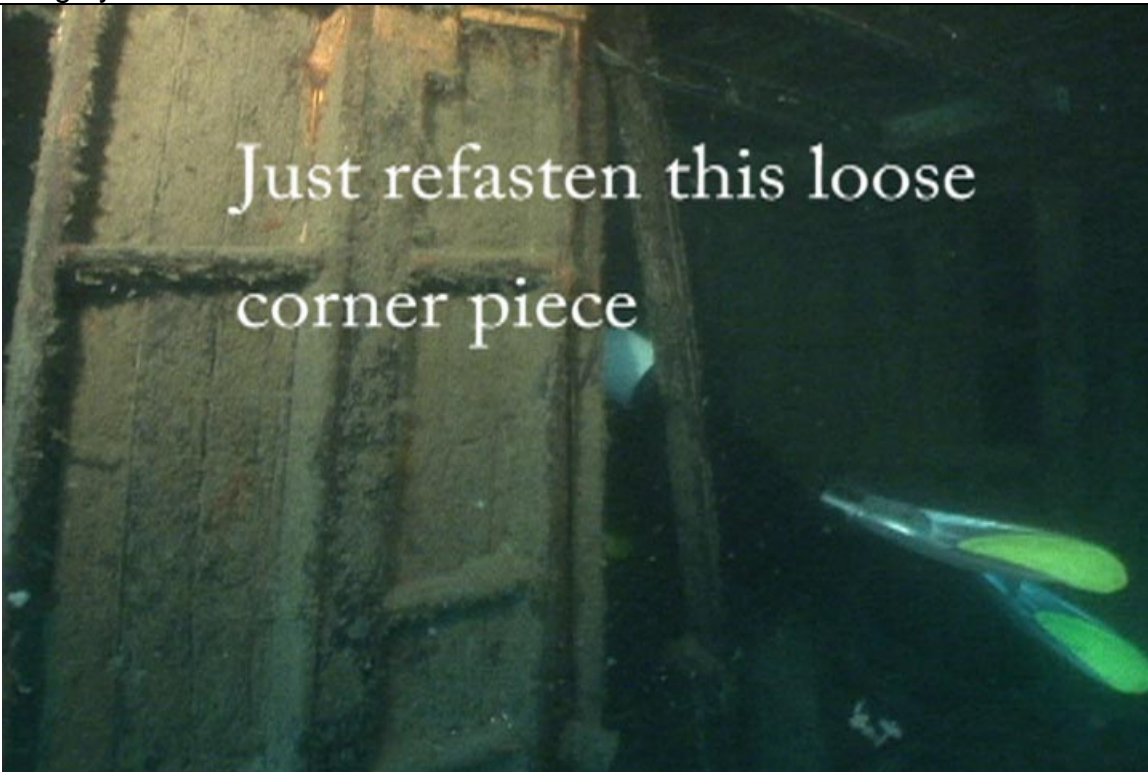
The dangling corner piece from a different angle prior to the project.

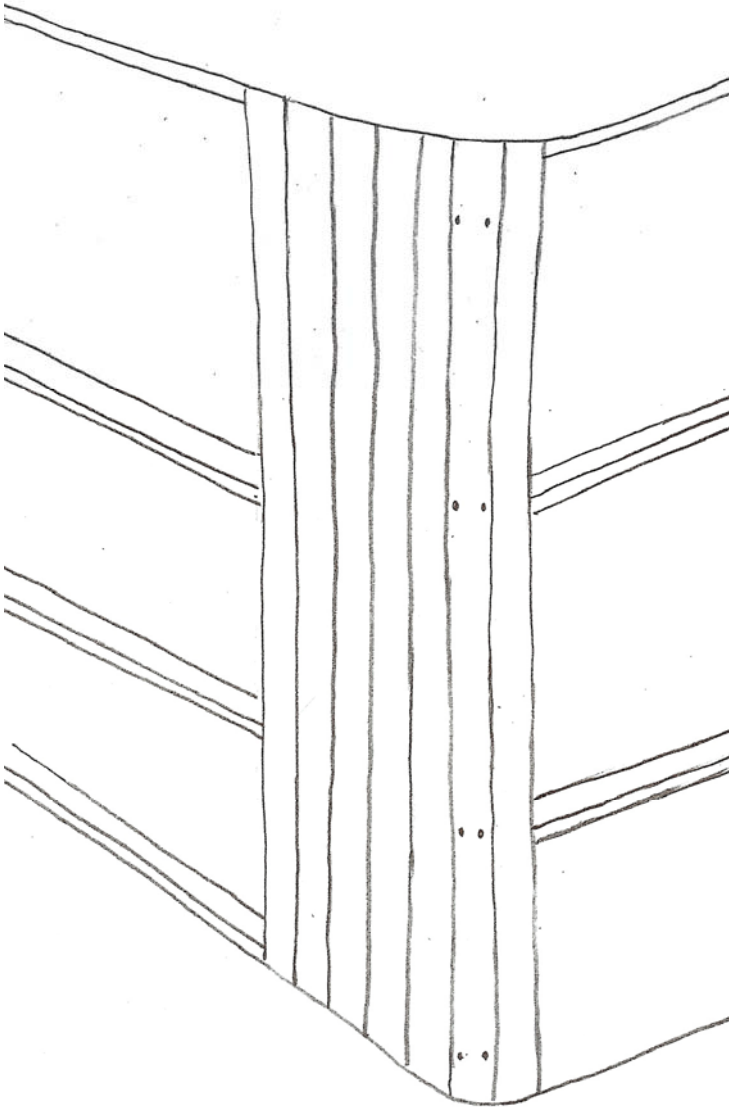
Illustration 3: Sketch artist Steve Daniel documented the completed corner task showing the screws added to fasten the corner piece to the backing boards.

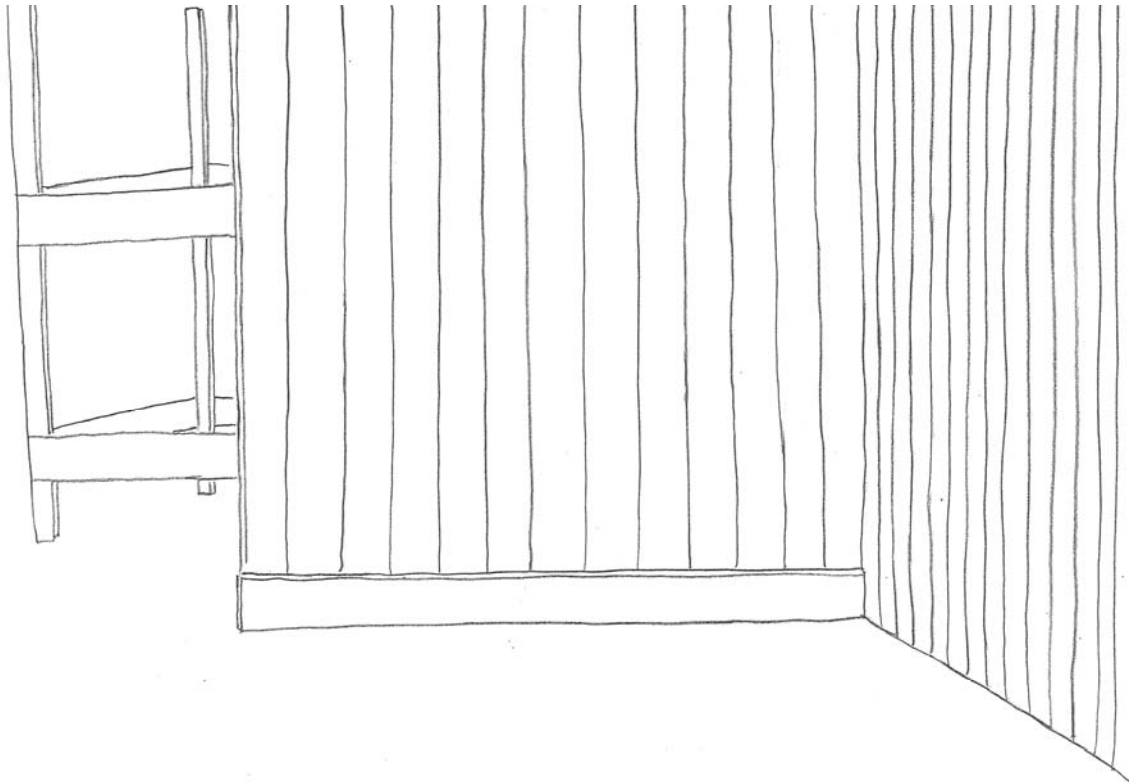
5. The bottom tongue and groove paneling of the longitudinal divider wall in the crews' quarters was loose from the base plate. We added a four inch base board to sandwich it in place to the 2"x4" base plate. The bottoms of some of the paneling boards are getting too soft to fasten each board individually.

Illustration 4: The horizontal base board was added to hold the vertical tongue and groove paneling in place. Some of the paneling boards are getting too mushy on the ends to screw them to the base plate individually, so we decided to use a base board as a retainer.

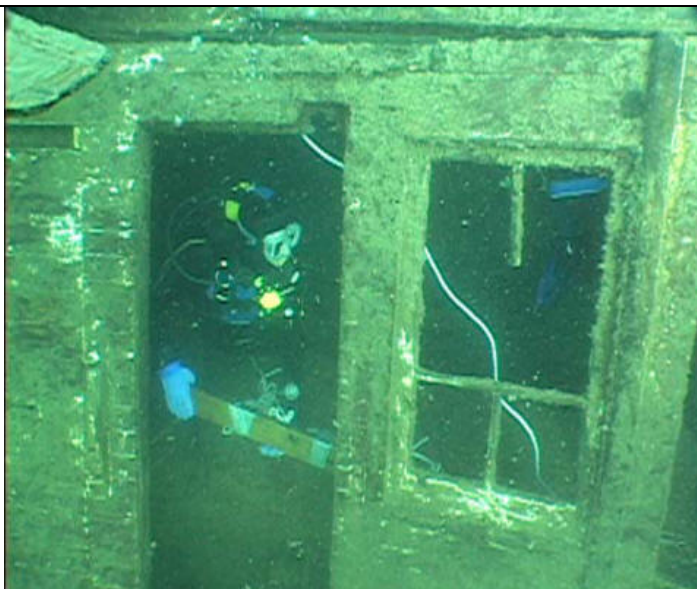
Rick Schmidt positions beam to support engine room wall in preparation to pull it into place.
