1994 *Samuel P. Ely* Restoration

Project Report

Kenneth Merryman
August 11, 1995

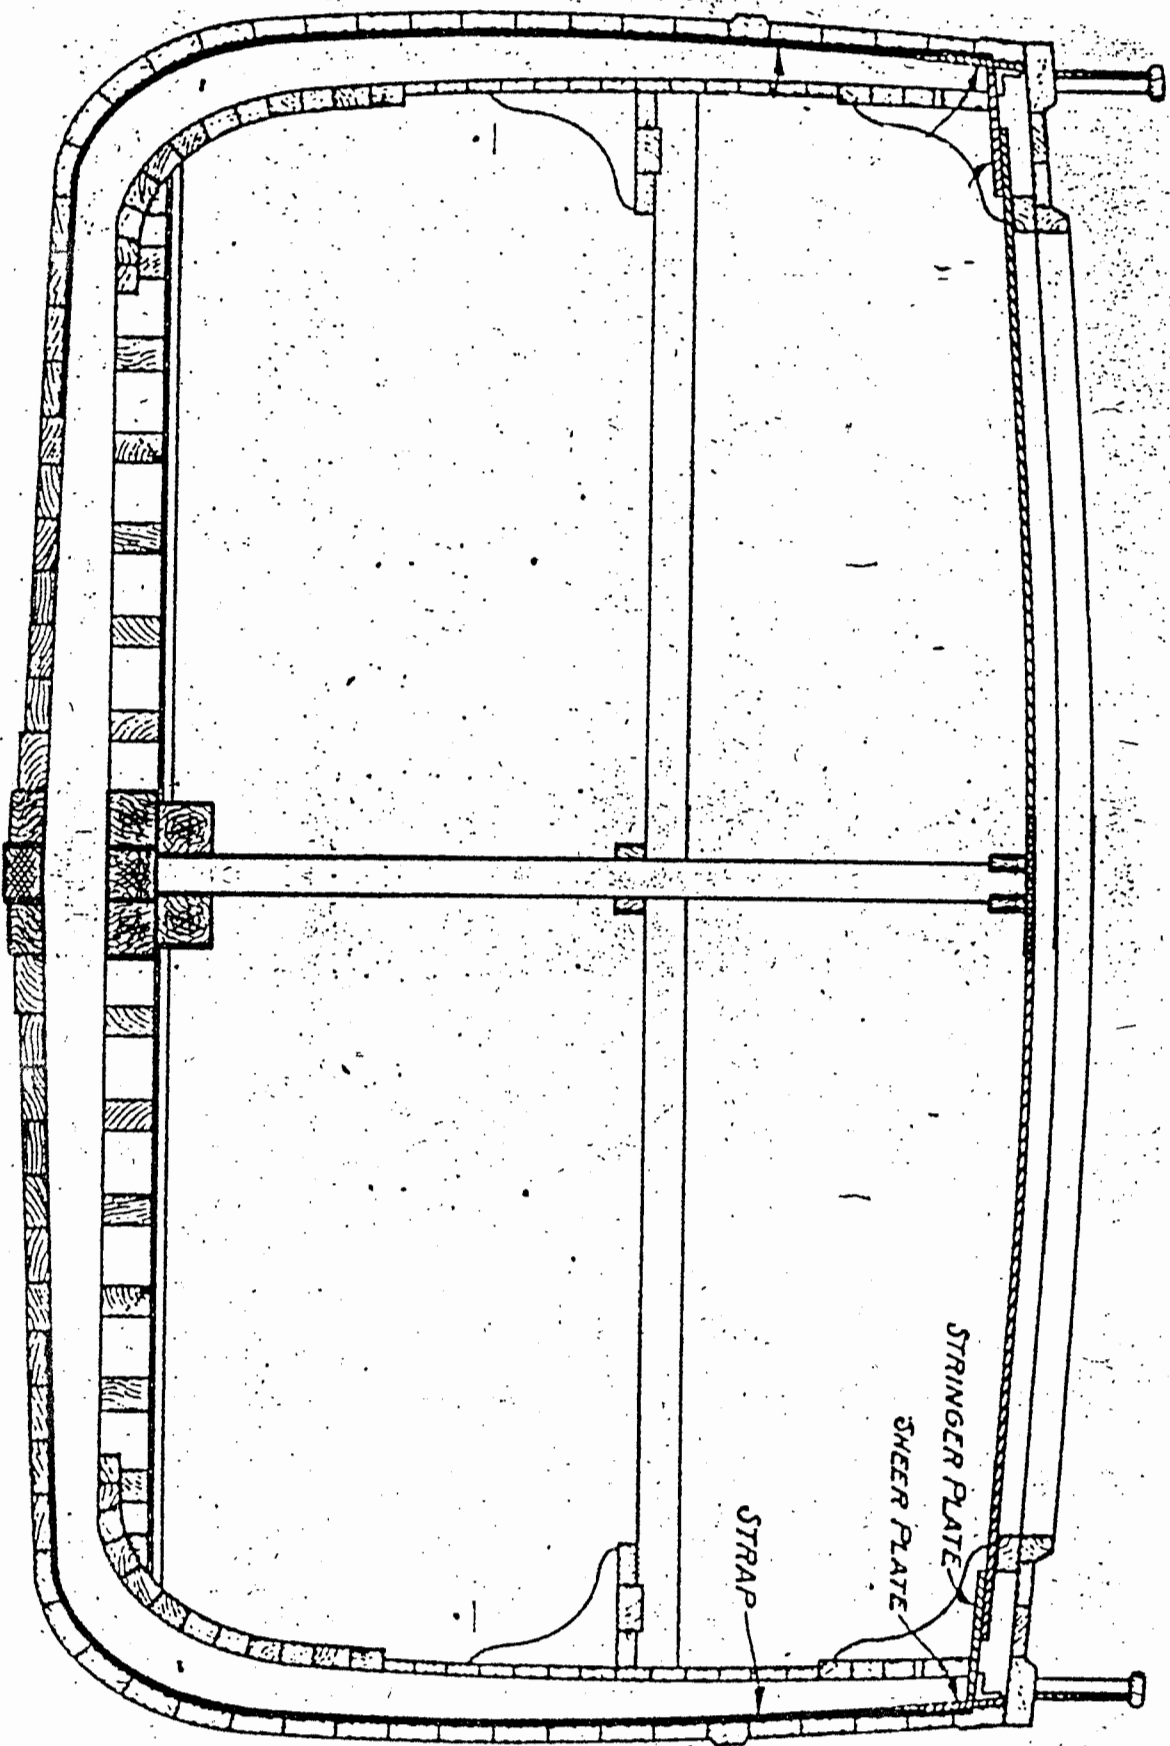
Figure 1 Typical Great Lakes Bulk Freighter Wooden Hull Construction

Site Description: To understand the deterioration that was occurring a background in early shipwreck construction is useful. Wooden ships built for the great lakes trade were basically flat bottomed wooden boxes with one pointed end. This construction was inherently weak in the corners of the ship where the sides met the bottom. The beams in the ship sides called futtocks were fastened to the bottom beams by wooden splices. The top of the box was the ship's deck. The deck of a wooden ship was supported by deck beams that were set on a shelf built into the sides of the ship (See figure #1). In later wooden bulk freighters there was often two decks although the lower deck was mostly only the beams and not fully decked over. The decks were also of much lighter construction than the sides of the ship. In order for the ship's hull to stay intact all four sides of the box need to be intact. If a ship's deck is removed or collapses there is no support to hold the sides erect and the whole structure can collapse.

As a shipwreck deteriorates, the lighter weight deck erodes away first. The splices at the junction of the sides to the bottom of the hull are not strong enough alone to hold the sides erect. Eventually the sides will fall over leaving only a pile of timbers or pieces of the hull. The *Ely* site has always been unique because, unlike most other wooden schooner shipwrecks, over half of it is intact. Its bow and stern broke apart long ago, but over 120 feet of the midship portion of the wreck is still upright and intact (See figure #2). The existing deck appeared to be holding the sides together and upright. The forward portion of the sides, however, protrude about 60 feet beyond the deck.

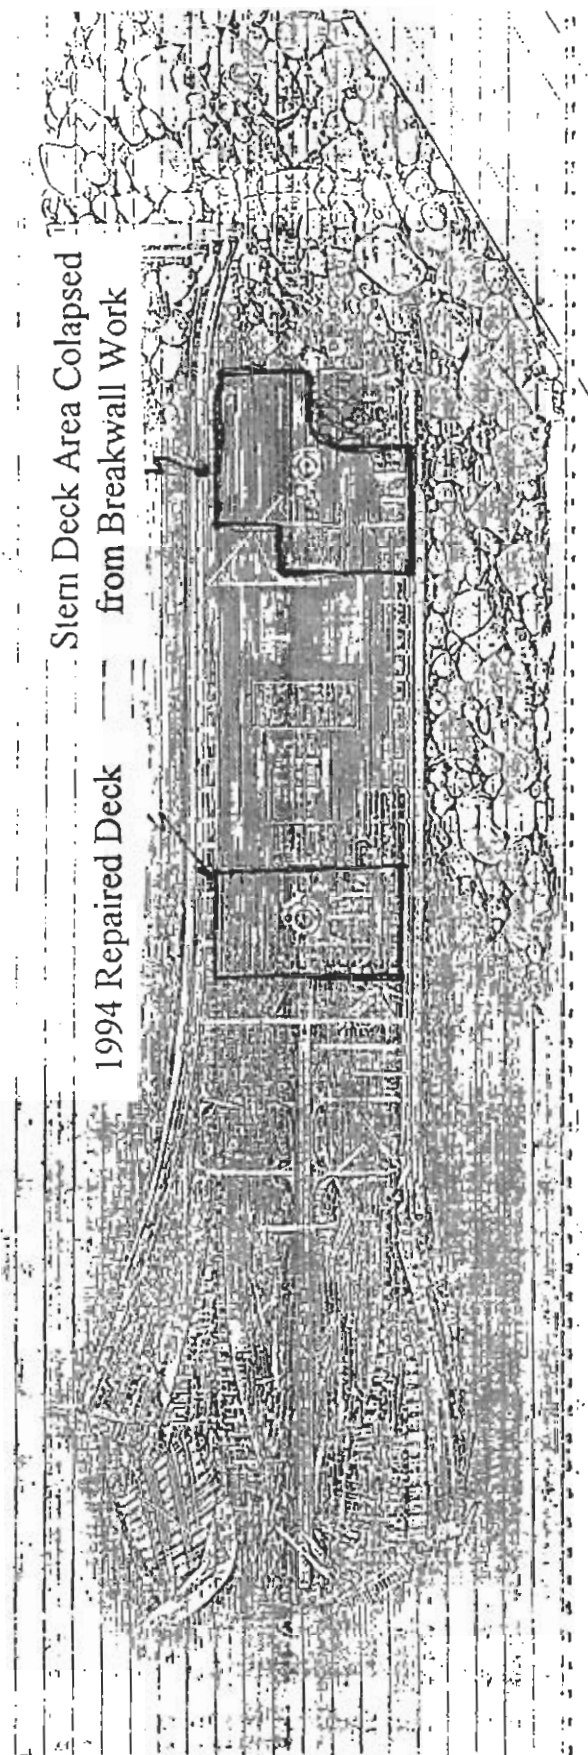
Figure 2

As they lean out, the weight of the structure has caused the sides that support the deck to spread. As the fasteners and deck beams have deteriorated, the hull has spread to the point that at the forward part of the deck the hull was wider than the deck beams. This caused a 20 foot section of the deck to collapse. If this process were allowed to continue, eventually the entire starboard side of the ship would fall to the outside and the entire deck would collapse. (See figure #3). For the *Ely* the rate at which this spreading was occurring accelerated considerably after the breakwall construction. Those of us that were monitoring the deterioration estimated that, if left unchecked, it would be less than five years until the wreck collapsed entirely.
