The 2007 SS America Project Report Addendum

By Ken Merryman
Project Manager

2007 Repair Tasks

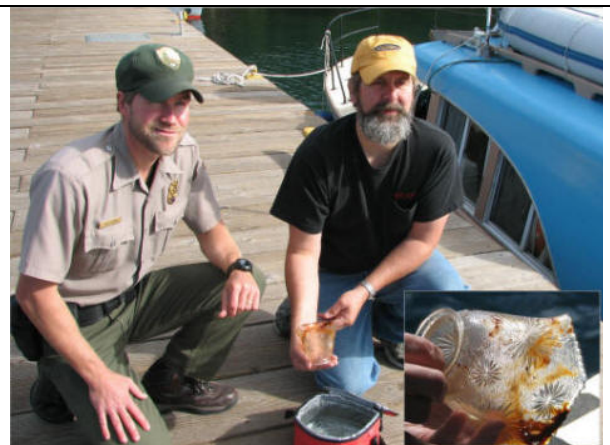
Bill Wallace made an amazing find in the wreckage of the assistant engineer's quarters--an intact globe from a wall sconce. The artifact was recovered and given to the park. The artifact will be used for the Windigo Visitor Center shipwreck display.

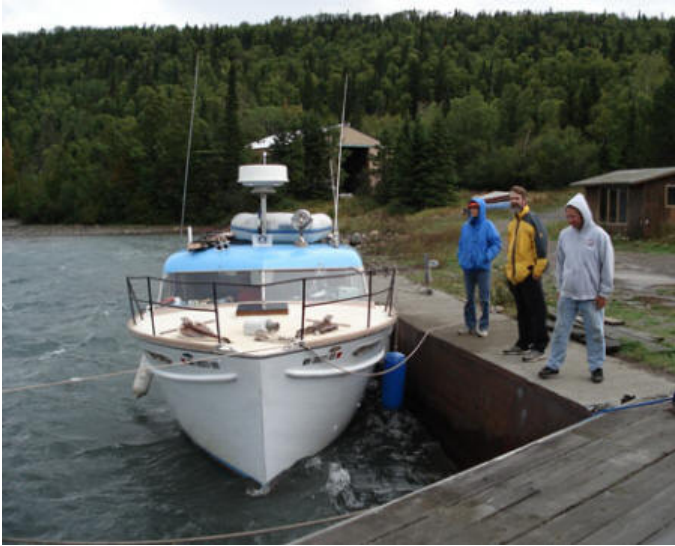
Heyboy pasted on the dock wall in 35 knot winds at the start of the project. Foul weather gave us a late start on the first day.

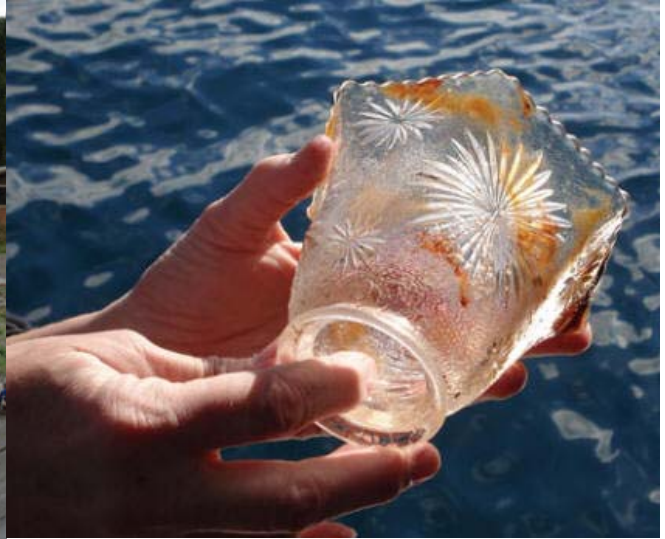
The intact wall scone globe gives us a better idea of what the furnishings of the *America* were really like.

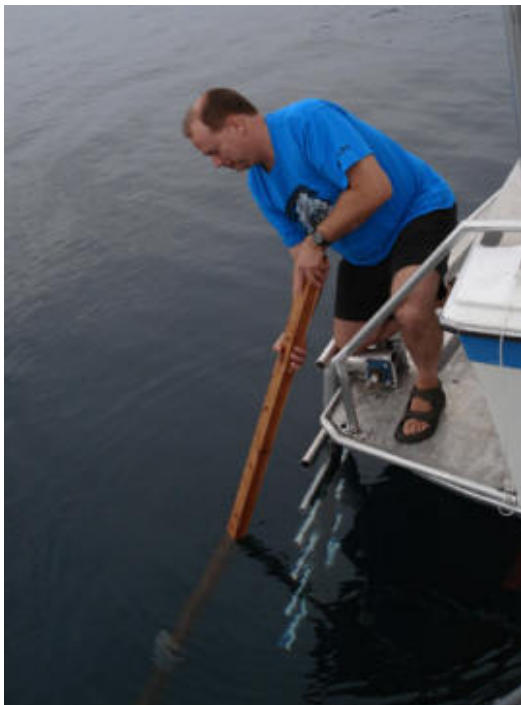
All new wood has to be weighted to make it neutrally buoyant underwater. Phil Kerber checks the buoyancy before sending down the new wall header.
